DEPARTMENT OF TRANSPORTATION**DIVISION OF ENGINEERING SERVICES**

Quality Assurance and Source Inspection

Contract #: 04-0120F4Cty: SF/ALA Rte: 80 PM: 13.2/13.9File #: 1.28**WELDING INSPECTION REPORT****Resident Engineer:** Casey, William**Address:** 333 Burma Road**City:** Oakland, CA 94607**Report No:** WIR-028797**Date Inspected:** 30-Nov-2012**Project Name:** SAS Superstructure**OSM Arrival Time:** 700**Prime Contractor:** American Bridge/Fluor Enterprises, a JV**OSM Departure Time:** 1530**Contractor:** American Bridge/Fluor Enterprises, a JV**Location:** Job Site

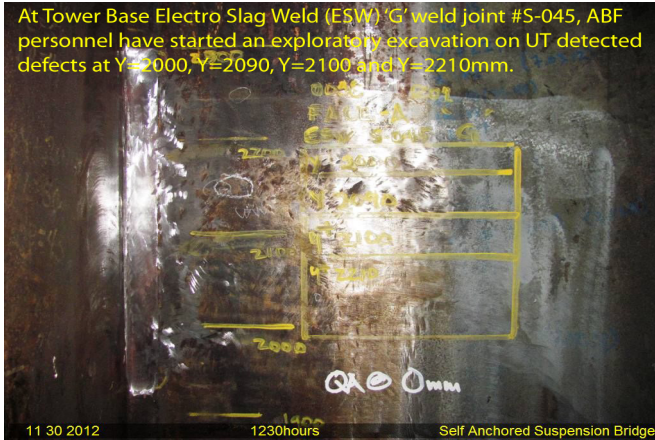
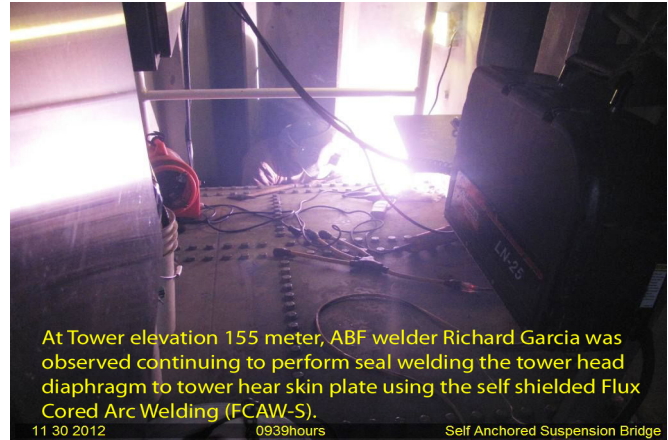
At Tower Base Electro Slag Weld (ESW) 'G' weld joint #S-045, ABF personnel was first noted flush grinding the weld cover of the welded ESW at locations Y=2000, Y=2090, Y=2100 and Y=2210mm for the start of exploratory excavation on the UT detected defects. After the completion of the flush grinding on mentioned Y locations, ABF QC Jesse Cayabyab was observed performing Magnetic Particle Testing (MT) on the flush ground surface with no significant indication noted. This QA also performed the same test and noted same result. Per given instruction to the ABF personnel, the exploratory excavation will be done in every 1 mm increment that should be MT tested

and recorded. The ABF personnel continued the excavation at 1mm deep and then MT tested by ABF QC Jesse Cayabyab with no significant indication noted. This QA also performed the same test and noted same result. During the shift, the ABF personnel continued the excavation in 1mm increments using the same method of test and verification up to 4mm with same result. The shift was completed up to this depth of excavation.
